Laguna Creek Inter-Regional Trail Walking Tour Report

January 2022

Prepared by Civic Thread, formerly WALKSacramento
for GHD and the City of Elk Grove

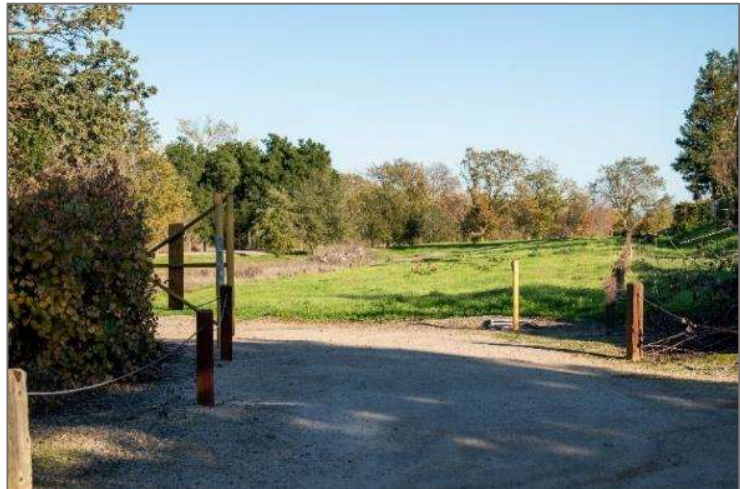
Several participants mentioned that they hadn't known about the trail until the walking tour. Both entrances to this trail segment are unmarked; the group noted that on the west end, the entrance looked like a service road and it was not clear whether you could enter or not. On the east end, the trail was narrow and part of a wider park, so it was not clear that it was a long connecting trail rather than just a park sidewalk. There was also minimal lighting at the entrances.

Figure 13. Open utility gate at west trail entrance (Francesca Street).

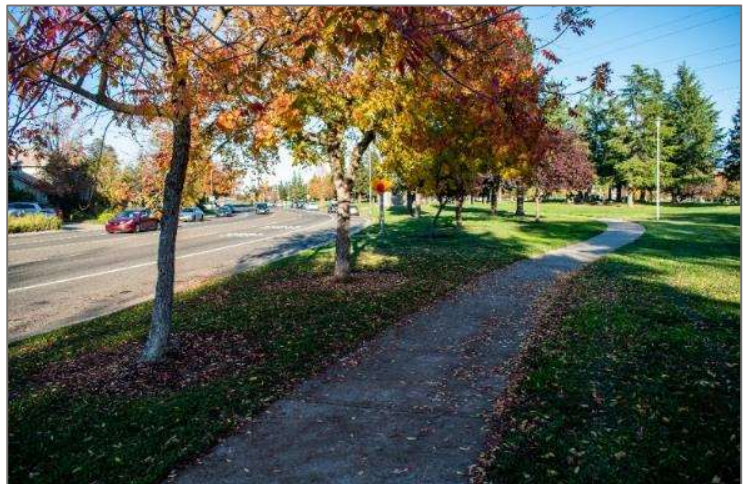
Though the trail is directly adjacent to the surrounding neighborhoods in several places, there are very few accessibility points for wheelchair users or users with other wheeled devices. For example, where the trail abuts Jacinto Avenue there is a very steep ramp and no curb cut. Several participants noted they have to carry their children's bikes when moving from the street to the trail.

Figure 14. At Jacinto Avenue a sidewalk that connects to the trail is directly parallel to the residential neighborhood but accessibility is lacking with no curb cuts.

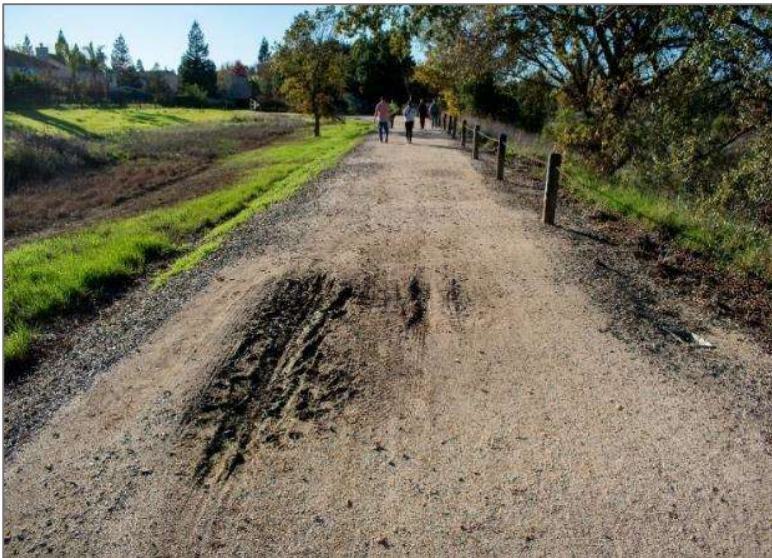
Several community residents noted that the decomposed granite portion of the trail makes it difficult for children riding bikes with training wheels, strollers, etc. One parent mentioned that when they take their children to the trail, they have to pick up the bikes and carry them past these unpaved portions. Wheelchair users would likely find it inaccessible as well. In some unpaved areas, there are spots with heavy erosion and ruts. Most of the paved areas are in good shape without many cracks.

Figure 15. Ruts due to erosion on unpaved portion of trail.

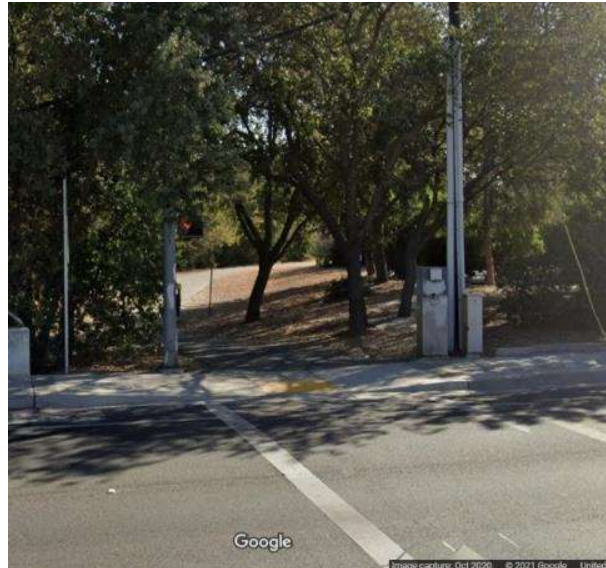
Figure 18. Example of overgrown tree branches covering pedestrian countdown signal. This is a screen capture taken from Google Maps dated from October 2020, however as of November 2021, the overgrowth identical and continues to present an issue.

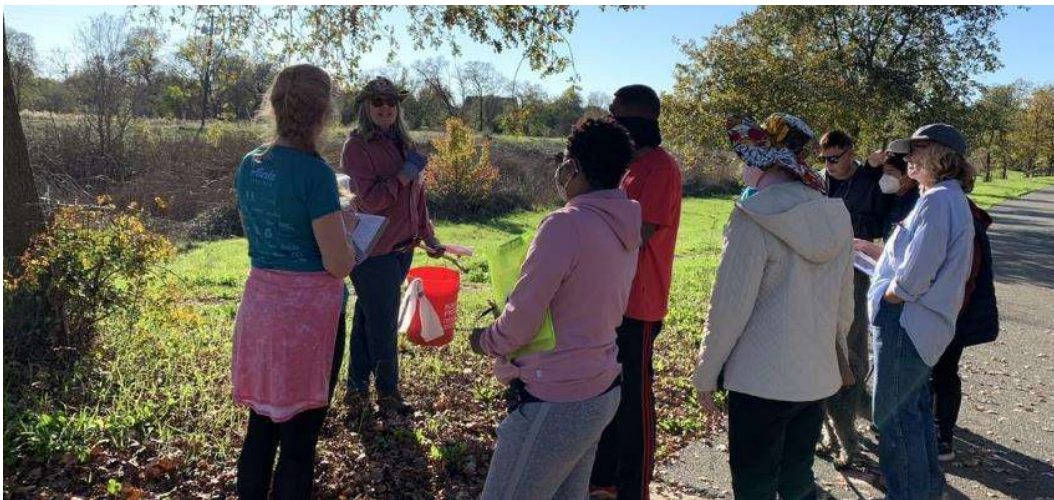
High volumes of trash were not seen until the walking tour reached the end of that part of the trail, where a drainage ditch is present. Large amounts of trash and plastic bags exit the drain and get stuck in the weeds, and require City of Elk Grove officials to maintain this hard to reach and hazardous area.

Figure 19. Trails Committee Member seen volunteering for trash clean up along the trail. It is reported that trash is frequently littered along the path due to lack of trash receptacles. Every Saturday, a group of community members meet to clean up the segment.

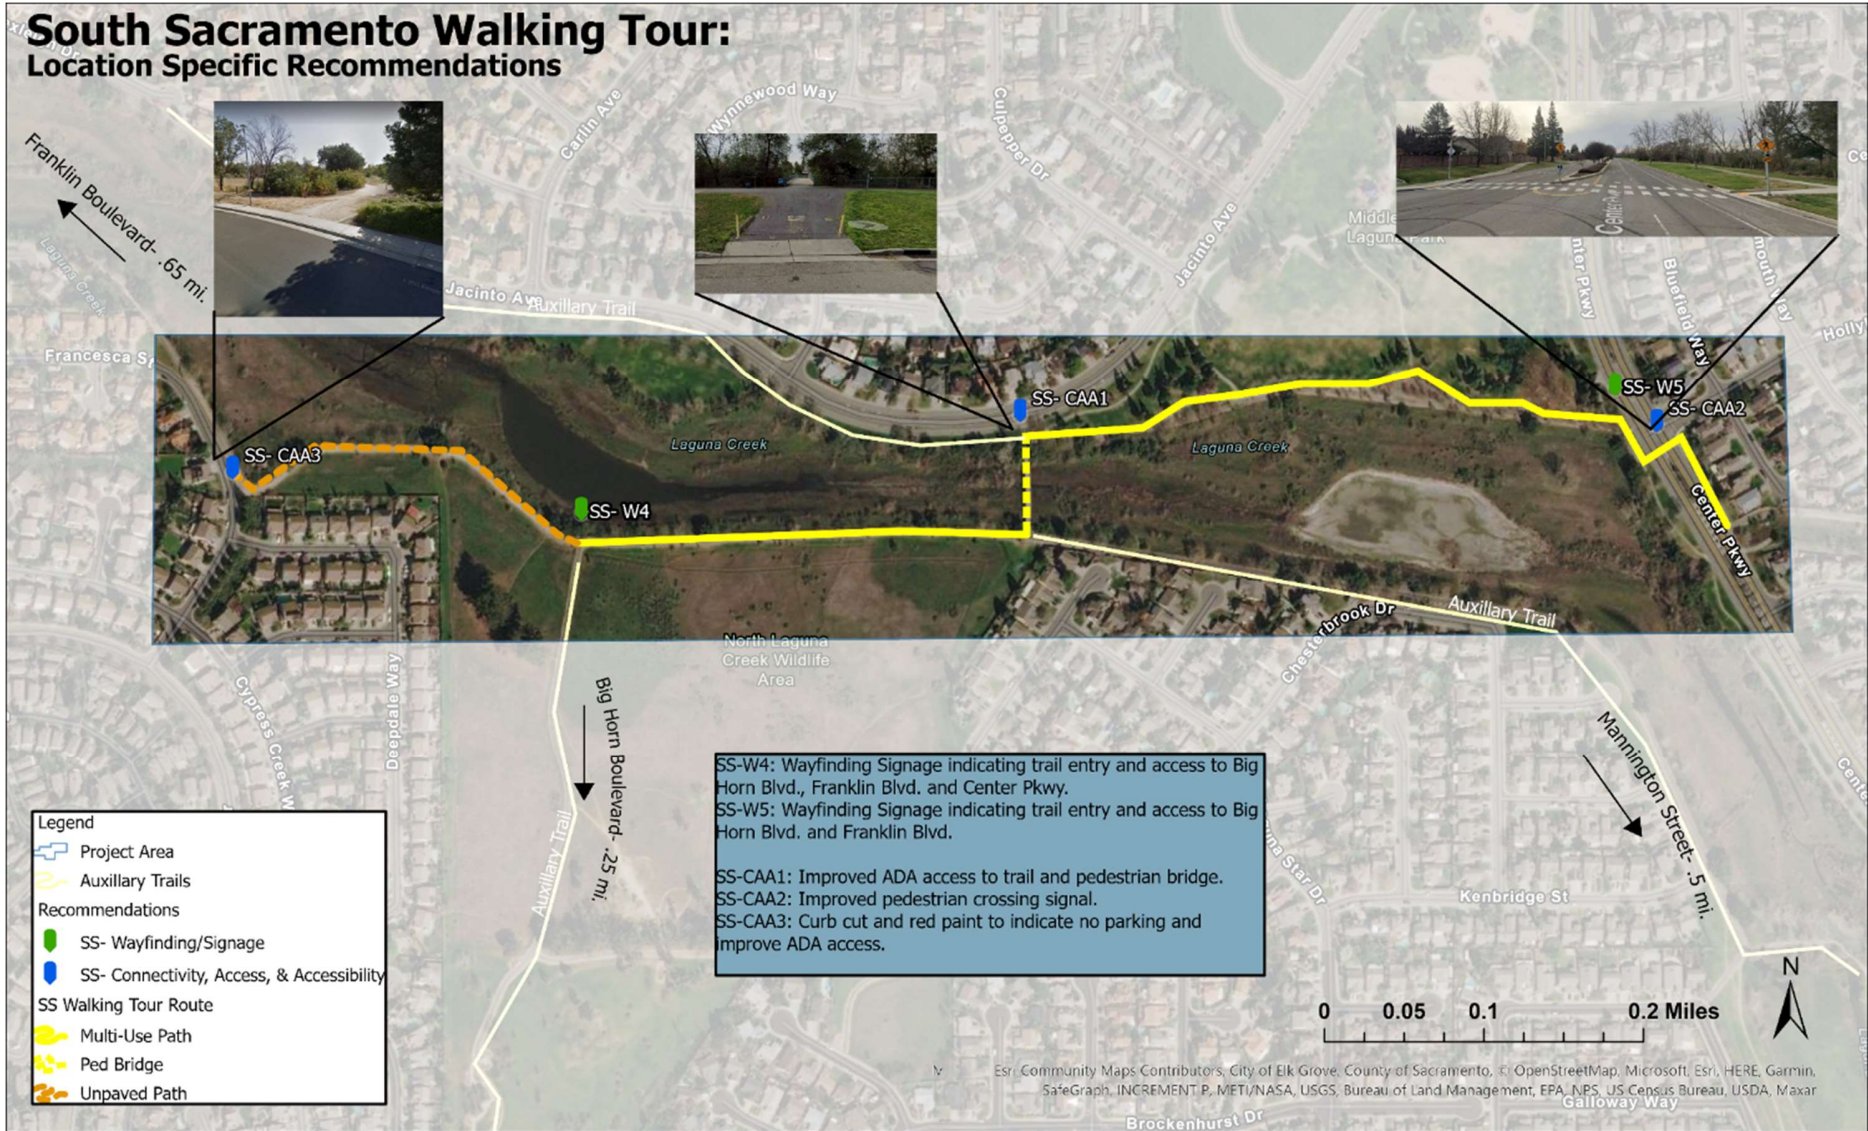
Figure 20. South Sacramento Walking Tour Map with location specific recommendations. If a PDF version of this map is needed, contact Pristina Zhang at pzhang@civictread.org.

See Figure 20, South Sacramento Walking Tour Map, for visuals to accompany location-specific recommendations.

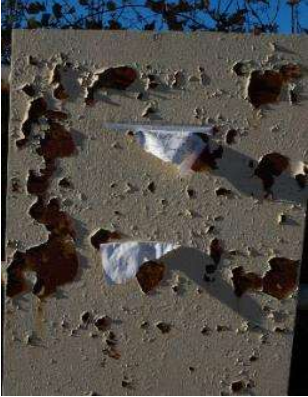
<p data-bbox="197 1323 491 1406"><i>Figure 22. Close up of sign on gate at western entrance at Francesca Street.</i></p> </div> <div style="text-align: center;">

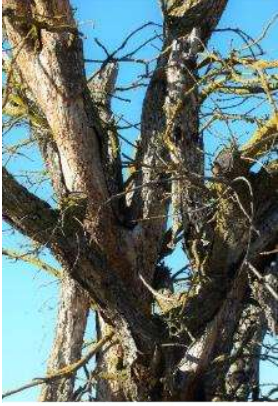
Community residents noted there were dead trees along the trail that seemed to have been infested with some sort of insect that made holes in the bark. Dead branches were falling off, and the group had concerns about it being a spreading infection and posing a hazard to trail users.

<p data-bbox="609 1328 817 1384"><i>Figure 21. Dead tree branches.</i></p> </div> <div style="text-align: center;">

ID	LOCATION	REPORTED OR OBSERVED CHALLENGES	RECOMMENDED IMPROVEMENTS
Maintenance			
SS – M1	Entire trail	<ul style="list-style-type: none"> • Educational signage in poor repair with faded and scratched surfaces and graffiti 	<ul style="list-style-type: none"> • Consider partnering with local neighborhood groups or Trails Committee to provide maintenance/cleaning of interactive programming elements
SS – M2	Entire trail	<ul style="list-style-type: none"> • Very few dog waste bag dispensers. Those that existed were full of trash. 	<ul style="list-style-type: none"> • Install additional dog waste bag dispensers at regular intervals along trail
SS – M3	Entire trail	<ul style="list-style-type: none"> • Dead trees with falling branches potentially infected 	<ul style="list-style-type: none"> • Assess tree health along creek and deploy any necessary interventions to avoid infection spread
Maintenance Visuals

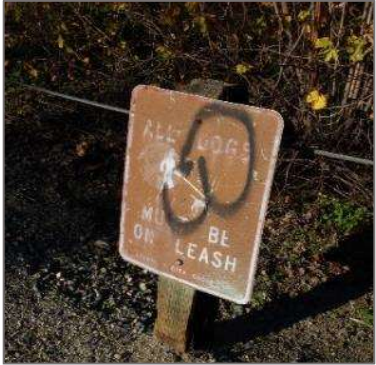
The South Sacramento trail segment had a number of signs that appeared to have once had educational content, but they were in poor repair and some were covered in graffiti. The condition of the signs contributed to an appearance of visual neglect.

The educational signage was in poor repair and no longer provided much value to trail users due to illegibility, though there is great potential to educate trail users about the natural landscape and the wildlife at Laguna Creek.

<p data-bbox="1018 1301 1289 1335"><i>Figure 23. Defaced signage.</i></p> </div> </div>			
Wayfinding/Signage			
SS – WI	Entire trail	<ul style="list-style-type: none"> • Wayfinding signs were present along the trail but lacked detail on distance to destinations • No trail network maps • Several unmarked offshoot trails 	<ul style="list-style-type: none"> • Provide trail network maps at entry points to trail segment • Provide wayfinding signs at entrance to offshoot trails indicating where they go • Revise wayfinding signs with distances in miles or minutes it would take a pedestrian or bicyclist to arrive at destination • Wayfinding signs should reflect consistent themes and visual styling along the duration of the trail segment

- b. Interpretive signs should be reinstalled to replace those defaced or missing. All placemaking efforts should be interactive and ADA friendly, and take care to reflect inclusionary language and imagery that reflects the diverse communities that live within the Sacramento region.

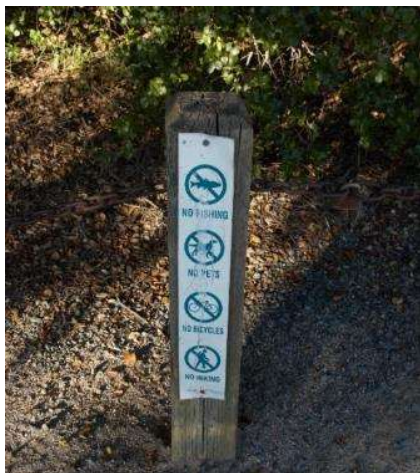
Figure 24. Sign that caused some confusion due to "no bicycles" language.

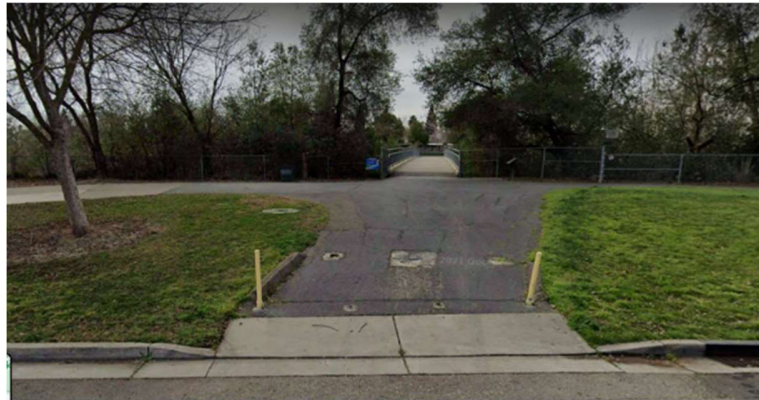
Figure 27. Google Maps 2021. Image of steep ramp connecting to Jacinto Avenue.

Connectivity, Access, and Accessibility			
SS – CAA 1	Where trail runs parallel to Jacinto Avenue	<ul style="list-style-type: none"> • Steep ramp from residential street to trail, noted by several community members to be too steep for accessibility • No curb cuts • No sidewalk along street 	<ul style="list-style-type: none"> • Short-term: Upgrade ramp with grading consistent with Americans with Disabilities Act standards • Medium-term: Include curb cut(s) to residential street in multiple locations • Long-term: Add sidewalks along south side of Jacinto Avenue • Long-term: Add pathways that connect curb cuts to trail
SS – CAA 2	East Entrance to Trail Center Parkway and Hollybrook Drive	<ul style="list-style-type: none"> • High traffic speeds • Vehicles slow to yield to pedestrians at RRFB • Long crossing distance • Inadequate accommodation for people on bikes 	<ul style="list-style-type: none"> • Consider replacing RRFB with any combination of the following: (a) overhanging pedestrian light, (b) stop signs for traffic in both directions, (c) rumble strips in advance of crossing • Consider a road diet on Center Parkway to reduce two travel lanes to one in each direction with center turn pockets. Reducing lane width would quiet traffic and allow for the current Class II Bicycle Lane to be upgraded to a Class IV Separated Bikeway that is buffered from the vehicle lane. If a road diet is infeasible given traffic volumes, consider narrowing the travel lanes in order to include a buffer to the bike lane.

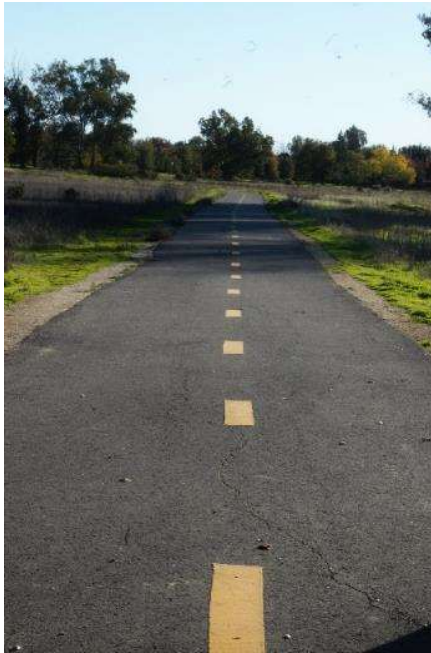
Figure 28. No speed stencils, signs, or other markings are present that might help pedestrians and bicyclists understand how best to share the trail.

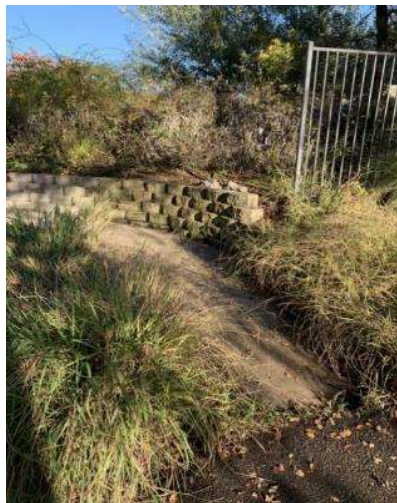
There is also a ramp from the plaza that can be used as a direct path to the trail. However, the ramp's alternate pathway is not easily visible and is concealed by foliage and requires further evaluation to determine if the ramp meets ADA accessibility standards. The paved path of this northwest part of the segment is roughly 15 feet wide and funnels into a slightly narrower path as it leads towards the south end off of Elk Grove Florin Road. Parallel to the paved path is a narrow shoulder that was unclear to community members if it was intended for use. During the walking tour, the City of Elk Grove staff clarified that space was intended to be offered as an additional path. However, the shoulder was surrounded by leaves and overgrown vegetation, and was not identified as a useable route by community members. To the east is Creekside Plaza, and to the west are the back of single-story homes that reside off Trout Way bordered by trees and natural growth. Throughout the path, there are a total of two seating areas, each location consisting of two sets of benches and posters that provide education about the local nature.

Figure 30. Overgrown foliage obstructing ramp access by northeast trailhead off Bond.

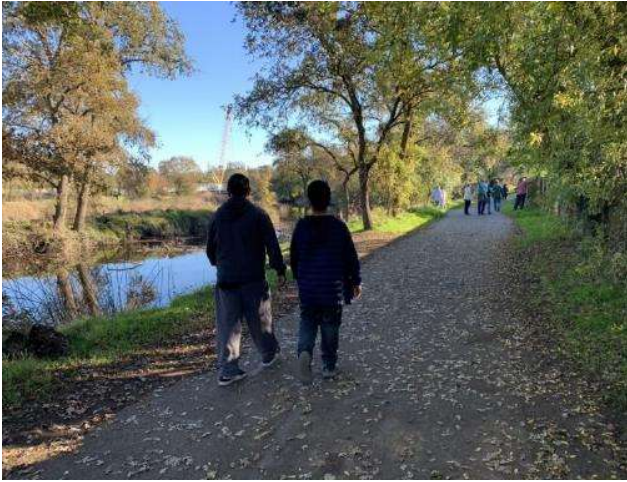
Figure 33. Example of unmarked routes on segment.

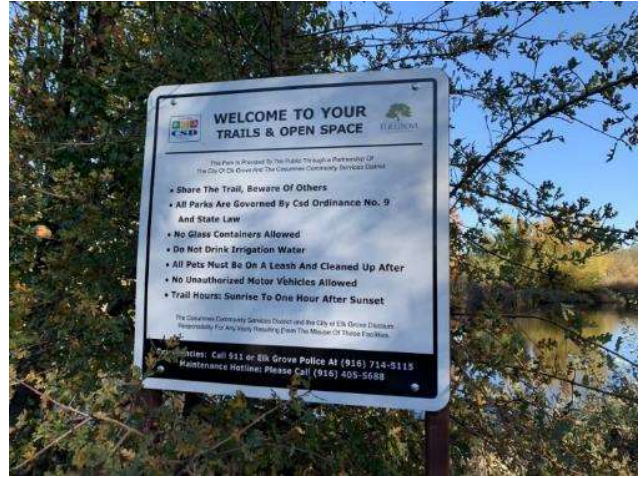
Figure 32. Only sign found during duration of walking tour. Located on southeast trailhead off Elk Grove Florin Road.

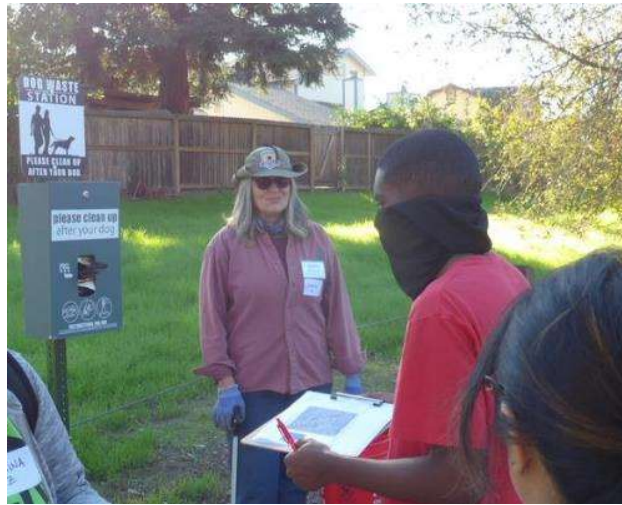
Dog waste bag dispensers were rarely sighted during the tour. At least one was observed and noted, however there could be more along the segment that the group did not reach. It was often mentioned by community members during the walk that dog waste bag dispensers are located far from each other and since they are out of reach when needed, often times they see users of the trail leave their pet's waste on the ground. Trash cans were also few but sighted more times than dog waste bag dispensers. No drinking fountain or water stations were present at any part of the trail, nor at the parking lot at the southeast trailhead of the segment. There also was no emergency call box present, however an emergency number was listed on the sign at the southeast trailhead.

Figure 34. The only dog waste bag dispenser seen during the 0.54 mile walking tour, pointed out by a Trails Committee Member.

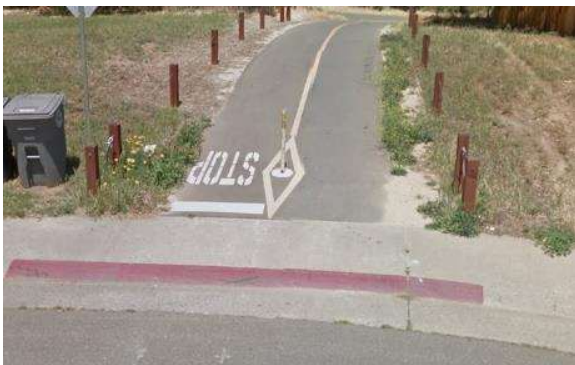
At the end of our walking tour, participants reached the cul-de-sac of Camada Court where it was observed that the red paint used to deter cars from blocking the trail entrance was faded and not clear it was a no parking zone. Cars blocking the trail entrance can obstruct access to the trail and can cause challenges for users of the trail who are accessing with mobility devices. A metal bollard in the center of the trail is intended to discourage vehicles from entering the trail, but may also create challenges for bicyclists navigating around the bollard—especially those pulling trailers, riding cargo bikes, or other nonconventional types of bicycles. In addition, there is currently no curb cut or accessibility ramp for ease of access to the trail entrance off Camada Court.

Figure 35. A photo taken from Google Maps Street View from 2015 that shows the original color of the paint. Currently this paint is faded and is not clear if it is a no parking zone.

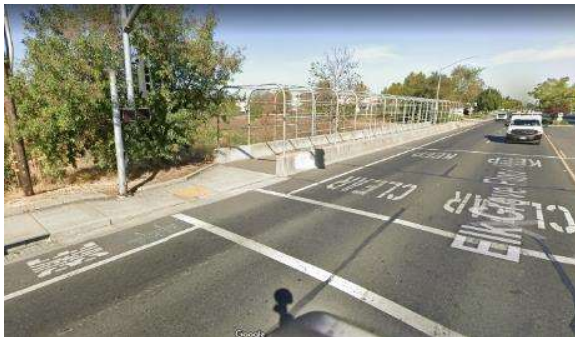
In this same location, coming out of the caged sidewalk is a tight turn for bicyclists who need to wait at or continue onto the crosswalk. The tight turn can be hazardous for bicyclists who are not strong at turning as it requires breaking and a sharp left, exiting the caged area. Additionally, this narrow space may create crowding if many people are waiting for the pedestrian countdown signal, or are prevented to continue onto the sidewalk if there are people crowding the waiting area to cross. The height of the push-button may also pose a challenge to bicyclists or horseback riders who need to reach the button to activate the crossing signal.

Figure 36. A photo taken from Google Maps Street View from 2020 showing the narrow space just outside of the caged sidewalk forcing bicyclists to make a sharp left turn to cross or wait for the pedestrian signal.
